# Concerns of the Application of Lightning Protection Risk Assessment for Small Structures

**Abstract**—International Standards on lightning protection risk assessment (IEC 62305-2: 2010) are well accepted and applied in many parts of the world. During the last few years a large number of lightning related accidents, especially due to direct strikes, have been reported from Asia and Africa where the lightning struck objects are small structures. Information gathered from several investigations done on these cases have been used to determine the level of protection needed for these structures as per the standard risk assessment. In many cases the outcome was the none-requirement of any LPS for such structures or a risk factor for direct strike probability which is less than the critical value. As there are millions of similar structures in these regions, we propose the development of a separate risk assessment algorithm for such structures, especially in underdeveloped countries.

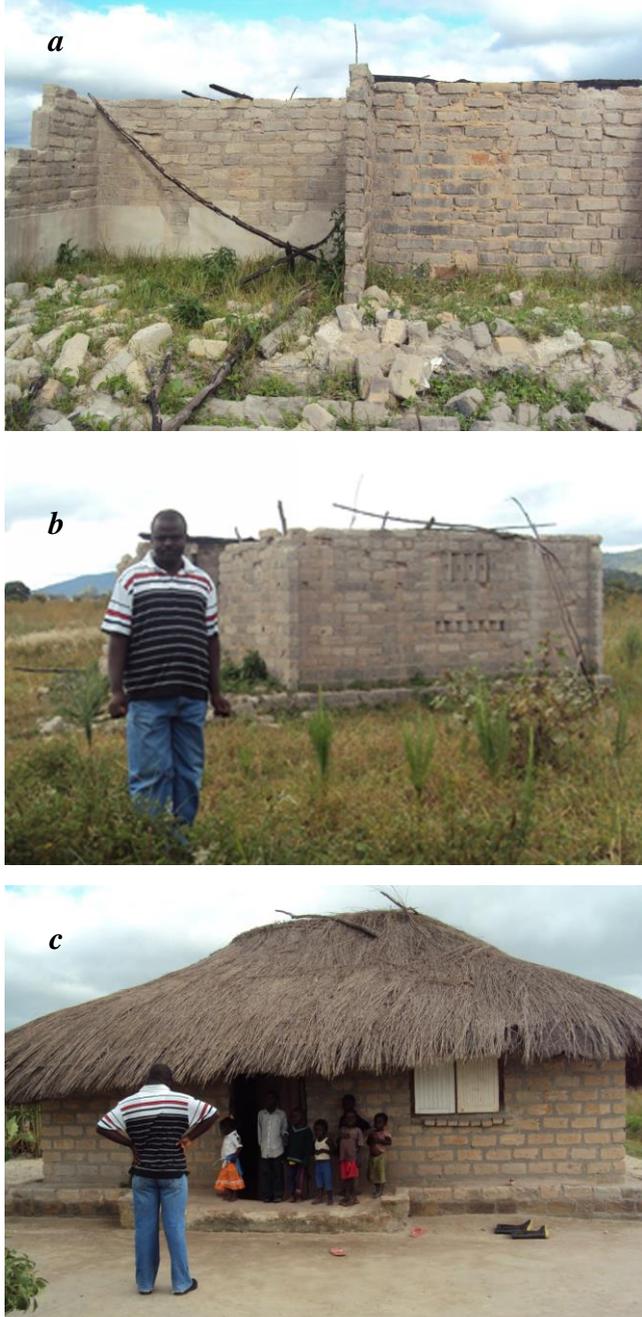
Case-1: Lightning has struck a small thatched roofed house (Figure-1) in Kasansama village, Mkushi, Zambia (14.00° S, 29.50° E). Five people of a family (out of six members) who occupied the house at the moment of strike were killed as the

thatched roof caught fire after lightning struck the structure. The only survival was a three year old boy. The wall materials were cement blocks and the floor was pressed clay. A neighboring building, very similar to the affected house, is shown in Figure-1c for the purpose of comparison. It is a flat area with typical village structure (houses are spread but not isolated). The dimensions of the affected building has been estimated as 5 m × 4 m x 3 m with highest point about 4 m.

Figure-1: The lightning struck structure in Kasansama village, Mkushi, Zambia. *a.* The close up of the building. *b.* Building at a distance. *c.* A neighboring building, very similar in dimensions and structure to the affected one (Adopted from [4]).

- Risk of direct strike ( $R_d$ ):  $1.098 \times 10^{-7}$
- Risk of indirect strike ( $R_i$ ):  $9.713 \times 10^{-6}$
- Calculated risk for loss of human life ( $R$ ):  $9.821 \times 10^{-6}$
- Tolerable risk for loss of human life ( $R_T$ ):  $1.005 \times 10^{-5}$

Thus, as per the risk assessment no protection system is required for the said building.

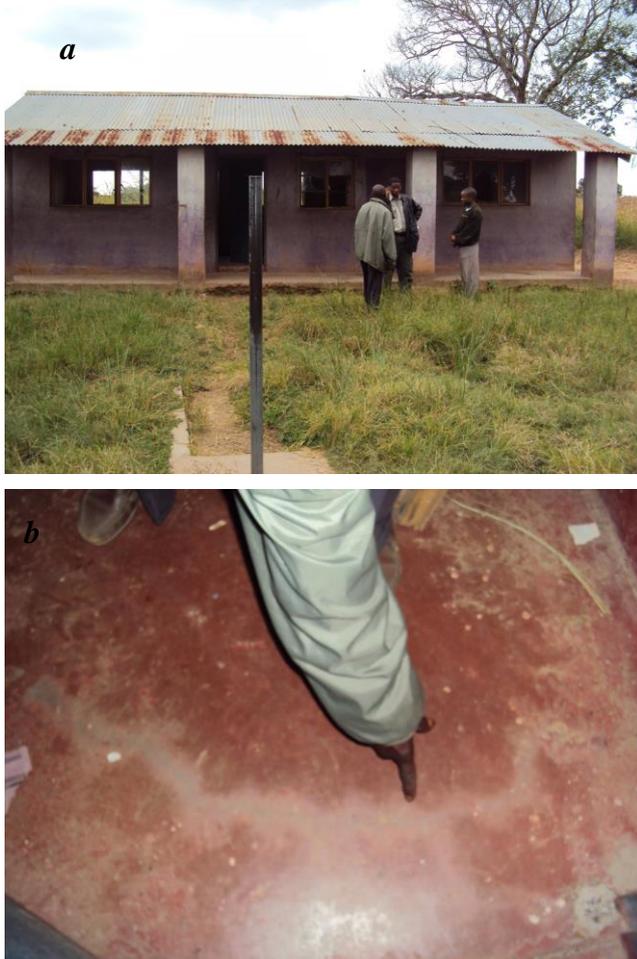
Case-2: Lightning has struck a small tin roofed school building (Figure-2) in Chibombo, Zambia (14.68° S, 28.10° E). According to the district police reports five students in the age of 12-13 years have been affected by a lightning strike to the building. All of them were injured while one have been found with severe burns. Eye witness and other observations revealed that lightning has struck a nearby tree and a side flash or surface current has been directed to the building. Damage marks visible on the cement floor inside the building (Figure-2b) indicates that a heavy lightning current has traversed into the building. The building is usually occupied by about 20 people for about 8 hours on every weekday. The area is flat with several buildings in the near vicinity. The dimensions of the affected building has been estimated as 10 m × 8 m x 3 m with highest point about 4 m.

- Risk of direct strike ( $R_d$ ):  $1.317 \times 10^{-6}$
- Risk of indirect strike ( $R_i$ ):  $4.000 \times 10^{-5}$
- Calculated risk for loss of human life ( $R$ ):  $4.132 \times 10^{-5}$

The outcome shows that the building needs protection, basically, due to the risk of indirect strikes. Thus, if such school building is a point of concern, the lightning protection engineer could develop a suitable design. However, there are two major issues arises with the above result and consequential outcomes.

Figure-2: The lightning struck structure in Chibombo, Zambia. *a.* The building. *b.* Damage mark on the floor of the structure suspected to be due to lightning current

- a.* It can be seen that when the risk assessment is redone with the modification of providing SPDs according to IEC 62305-4: 2010 [13],  $R$  reduces to  $1.337 \times 10^{-6}$  even under the condition of no external LPS. Thus, the risk assessment implies that the building is safe with surge protection. However, the observations on the above incident clearly show that surge protection could not avoid the lightning mishap, as it is related to a direct strike followed by side flash or surface current. On the other hand most such rural buildings in Africa do not have electricity.
- b.* The second issue is the safety of similar buildings which are not categorized under schools/ hospitals/ hotels etc. There are many buildings of similar

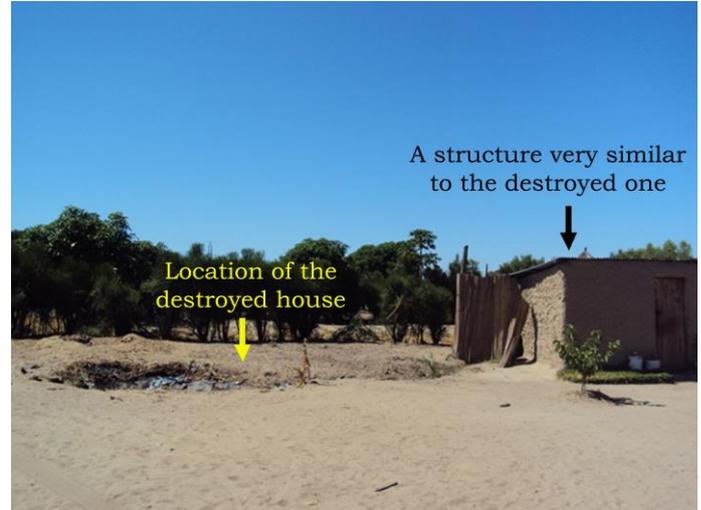
Case-3: This is also a structure from Zambia located in the village Katuya in the township Senanga ( $16.12^\circ$  S,  $23.27^\circ$  E). Lightning has struck the building while the single occupant who used to live in the house alone (during the night time) was sleeping. He was killed and the building was completely destroyed creating even a small crater at the location (Figure-3). The house was similar in size and structure to the one adjacent to that where his siblings live.

The structure is made of clay and roofed with corrugated metal sheets. Its dimensions were approximately  $4 \text{ m} \times 3 \text{ m} \times 3 \text{ m}$  with maximum height of the roof is about 3.5 m. The ground flash density was considered as the same as in the previous cases. The following results have been obtained in the risk assessment.

Risk of direct strike ( $R_d$ ):  $1.089 \times 10^{-7}$   
 Risk of indirect strike ( $R_i$ ):  $5.550 \times 10^{-6}$   
 Calculated risk for loss of human life (R):  $5.659 \times 10^{-6}$

Again  $R < R_T$  indicating that the structure does not need any protection.

Figure-3: The lightning struck structure in Katuya, Zambia.

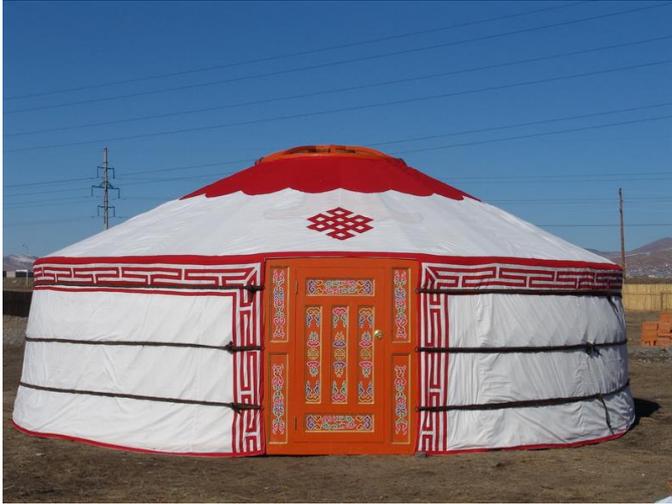
Case 4: Mongolia is a country with comparatively low lightning density that varies between  $0.6$  to  $6 \text{ flashes yr}^{-1} \text{ km}^{-2}$ . Most of the rural houses in the country are cotton surrounded structures named ger (Figure-4). These structures could be seen even in townships. As it is reported in [11], during the last decade, several lightning related accidents have occurred while people were inside such gers. As the details of each case are not extensively available, we consider one on the incidents from central province where a nine year old child was killed by lightning while the family was inside.

Typically a ger has a diameter of about 8 m, thus the area is approximately  $50 \text{ m}^2$ . The number of people in the family who lives in the ger was considered as 4. The height of the lower roof plane and maximum height was considered as 3 m and 4.5 m respectively. The affected house was in a flat land in a village. Usually they have pressed clay floor. The family was assumed to occupy the house for 16 hours a day for the whole week. We considered the maximum ground flash density for Mongolia, 6, in our calculation.

Risk of direct strike ( $R_d$ ):  $2.118 \times 10^{-7}$   
 Risk of indirect strike ( $R_i$ ):  $7.400 \times 10^{-6}$   
 Calculated risk for loss of human life (R):  $7.612 \times 10^{-6}$

This is another case of a lightning struck building which has been predicted as having no lightning risk, without implementing any class of lightning protection system, according to the risk calculation. There are thousands of such structures in same environment in Mongolia and the neighbouring countries with similar isokeraunic level.

Figure-4: Typical ger in Mongolia

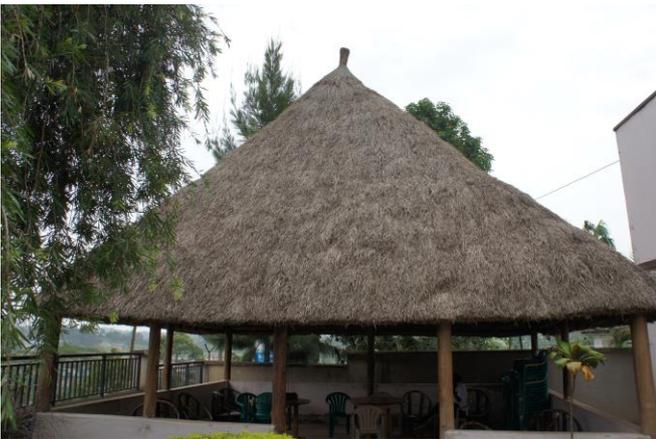
Case-5: A lightning strike set fire to the visitors lobby Cheetah Conservation Centre, in Otjiwarongo, Namibia (20.46° S, 16.65° E), injuring an intern employee and burning down the building. There was only a single person in the building at the time. One of the authors who travelled to Namibia, has been informed that similar accidents are somewhat common in many parts of Namibia. Most often the lightning strikes cause lethal injuries both due to lightning current effects and burning of inflammable materials. The analysis has been done on a structure similar to the one that was destroyed at Cheetah Centre, we assume that a family of 4 lives in the building and it is located at Otjiwarongo, Namibia. The floor of the building was assumed to be concrete and the floor area was considered as 36 m<sup>2</sup>. The selected housing structure is shown in Figure-5.

Figure-4: A structure similar to the one of concern in Namibia.

Risk of direct strike ( $R_d$ ):  $1.603 \times 10^{-7}$

Risk of indirect strike ( $R_i$ ):  $3.150 \times 10^{-6}$

Calculated risk for loss of human life ( $R$ ):  $3.31 \times 10^{-6}$
