# Implementing a Lightning Protection Solution for Multi-Structure Orphanage in Haiti

**Abstract**—This paper discusses the response of the United States lightning protection industry to a request for help from an orphanage in Haiti that addresses the educational and social needs of the poorest of the poor. The methodology used in this response can be applied to other applications to provide lightning-safe structures protected in accordance with national and/or international lightning protection standards. From the perspective of a developing nation, there is a benefit to working with non-profit organizations involved in lightning safety as they can provide the contacts necessary to properly assess the needs of the organization and implement the solutions required.

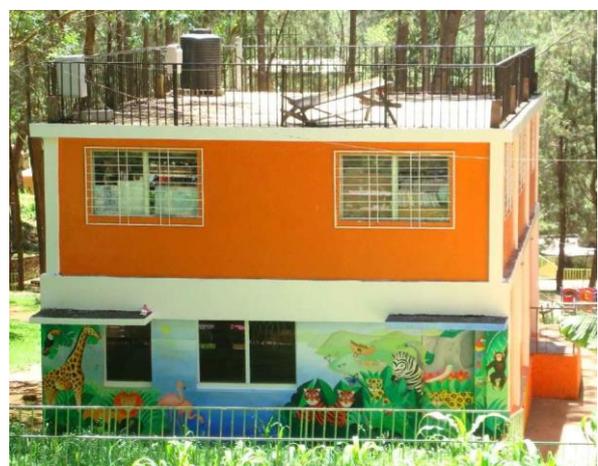
Figure 1. St. Helene’s Home Bakery

Fig. 1 provides an example structure to discuss a typical design. The roofs of most structures are accessible for normal human traffic. All water used at the site is captured from rain water or trucked up the mountain from Port au Prince. For this reason, most of the structures contain at least one rain barrel such as the one seen on the right rear of the roof. To minimize the amount of material required to be transported to the site, maximum use of natural air-termination components is used. In this example, the hand rails around the perimeter of the roof served as the perimeter air-termination, supplemented by an air terminal mounted on the hand rail at the right-front electrical box and at the water barrel to provide a protected zone for these elements not protected by the hand rails. Steel reinforcing bars protrude through numerous roofs. The individual reinforcing bars are interconnected and tied into roof system to also serve as natural air-termination components.

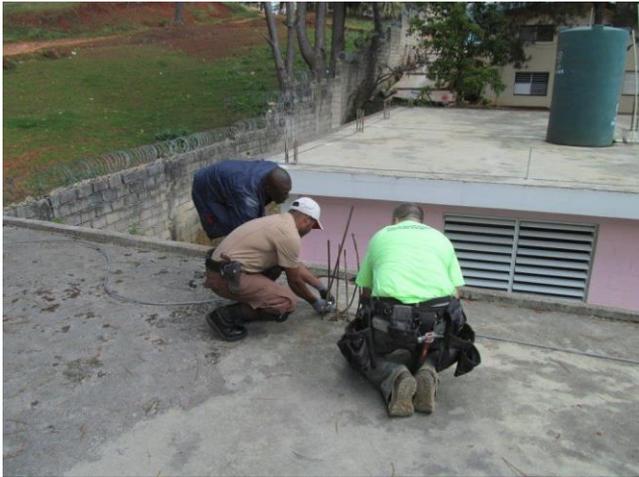
Figure 2. Installers making interconnection with reinforcing steel for use as air termination with completed structure in background

Fig. 2 and Fig.3 show examples of the installation of roof-top lightning protection and earth electrodes employed at the orphanage.

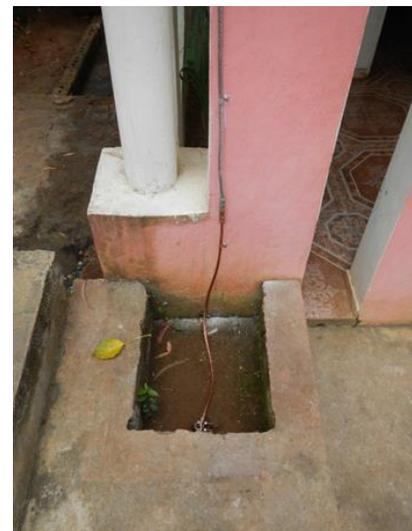
Figure 3. Earthing electrode showing aluminum to copper transition at down conductor

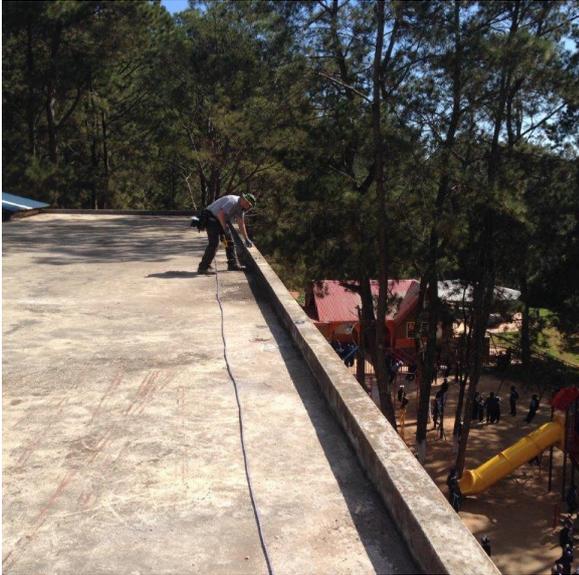
Figure 4. Installation of air terminal base on parapet wall on primary school

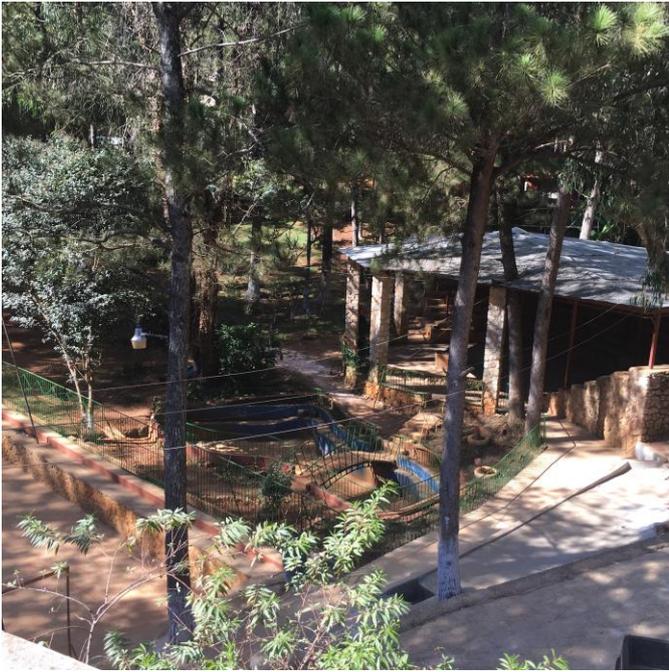
Figure 5. Example of density of trees on campus
