# Experimental Study of Round Steel Damage Caused by Lightning

**Abstract**—The surface of round steel often suffers from serious ablation under direct lightning stroke. The change in the internal structure and mechanical property of round steel at the ablation point is a topic deserving of study. In this study, we performed a simulated lightning stroke test on the round steel samples using impulse current generator, and conducted a tension test and a metallographic analysis on the samples afterwards. We found that in comparison with short stroke, long stroke is the real main cause for internal structure change and mechanical property impairment of round steel at the ablation point. After long stroke, the tensile strength of the samples decreased by 7.86%-13.68%, and obvious lightning stroke features like pores and cracks were observed at the internal structure. Therefore, high temperature effect of arc discharge by lightning stroke may damage the structure of metallic material and influence the structure safety of buildings (structures) under the joint action of building (structures) load and other factors. The metallic damage features can be taken as hidden forms of lightning ha

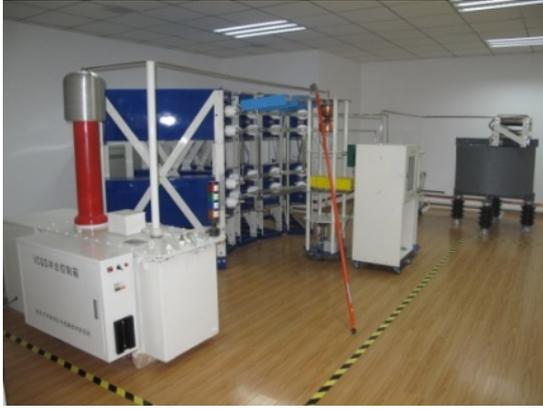
Figure 1. Impulse current generator

For the purpose of simulated lightning stroke test, we employed the impulse current test system developed by Chongqing Engineering Research Center of Lightning Disasters Identification and Prevention for pretreatment of the metal material sampled for this study. The test system can produce impulse current with 200kA amplitude and 8/20 $\mu$ s waveform and that with 20kA amplitude and 10/350 $\mu$ s waveform<sup>[7,8]</sup> as well as A+C component current waveform used to measure the direct impacts of lightning on structures. A+C component current waveform, that is the test waveform composed of initial peak current waveform (A component) + sustained current waveform (C component), was selected according to the definition of the waveform used for measuring the direct impacts on metal material structure prescribed in GJB3567-99 *Lightning Protection Qualification Test Techniques for Military Aircraft*<sup>[9]</sup> and the definition of the test waveform prescribed in GJB2639-96 *Lightning Protection of Military Aircraft*<sup>[10]</sup>. And the impulse current generator applied is shown in Fig. 1.

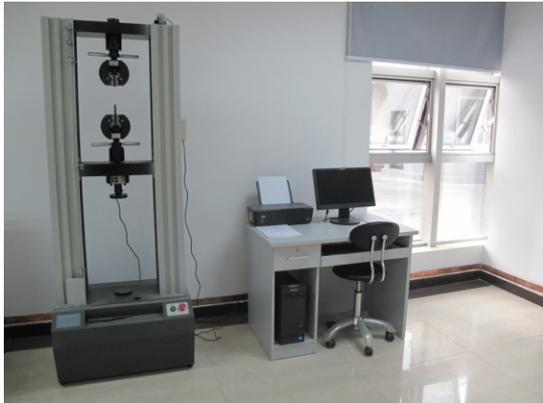
Figure 2. Electronic tension tester

The metal material properly pretreated for simulated lightning stroke test must go through mechanical property test to examine the change of its mechanical property after lightning stroke. And we used an electronic tension tester with a max. test force of 100kN, force measuring range of 2kN-100kN and beam travelling speed of 0.05-500mm/min for that purpose. The tension tester was connected to a computer so that test parameters can be calculated using system software, and such parameters as test force, displacement, peak value, running state, running velocity, test force range and tensile strength-displacement curve can be displayed clearly. The electronic tension tester is illustrated in Fig. 2.

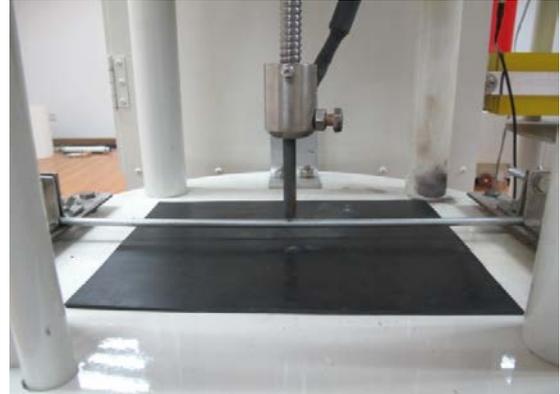
Figure 6. Test site layout

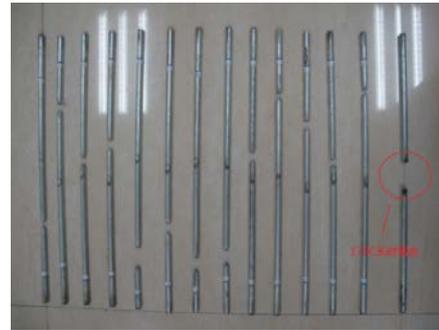
Figure 9. Comparison of tension test results following short stroke and long stroke

tensile strength of the galvanized round steel was not affected by short stroke within the permissible range of tensile strength error. We also noted in the tension test that the breakpoints of round steel struck by short stroke were distributed randomly throughout the steel instead of coinciding with the lightning strike point. As illustrated in Fig. 8, the red circles denote lightning strike points, while the black ones denote breakpoints of tension test. The round steel samples were struck by more short strokes from left to right; despite of that, the breakpoints still did not coincide with the lightning strike points. It suggests that short stroke only causes damage to the zinc coating on the round steel surface but not any structural damage to the steel. In the contrast, the breakpoints on the round steel struck by long stroke coincided with lightning strike points, as shown in Fig. 9, indicating that long stroke would cause damage to steel structure.
