# A Positive Lightning Discharge that Caused Severe Damage to the Blade of a Windmill

Daohong Wang, Norio Sawamura, Nobuyuki Takagi  
Department of Electrical, Electronic and Computer Engineering  
Gifu University  
Gifu, Japan

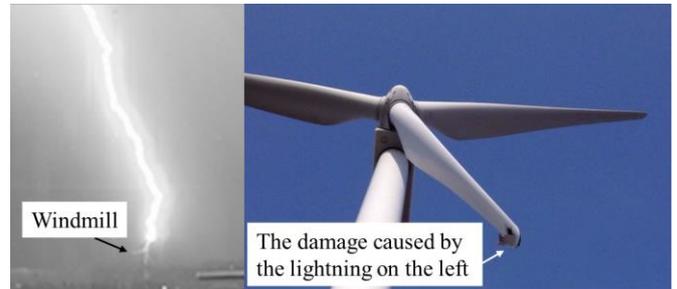
Figure 1. The picture of the lightning and the damage caused by this lightning.

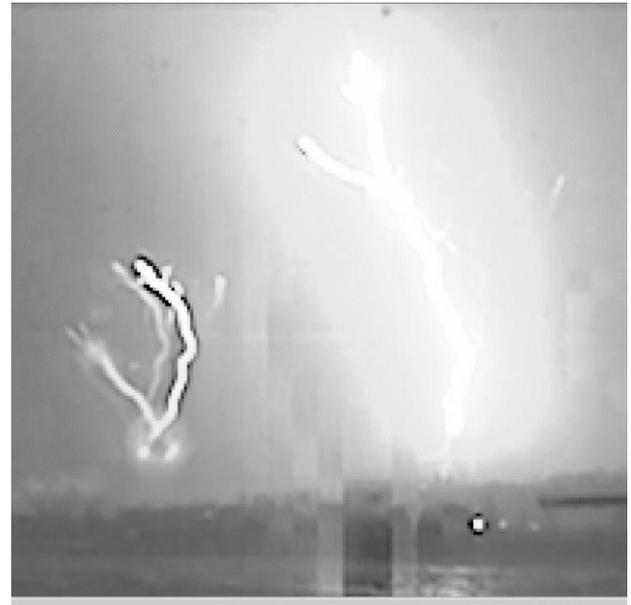
Figure 6. Photo of the upward negative connecting leader immediately prior to the return stroke type of discharge.
