The study of lightning strikes to common buildings in Brazil

Abstract—Most of what is known about the electric current of downward flashes and striking distance of lightning protection systems come from information gathered on tall towers. There are no observational data of lightning attachment to common structures or buildings (under 60 m) that are present in almost every city. In order to study lightning strikes to common buildings, several instruments were installed in and around two identical buildings located in São Paulo city, Brazil. This paper describes the setup of electric field sensors, current transformers, X-ray sensors, high-speed video and standard video cameras. Some of the data already obtained in its first two months of operation are also shown.

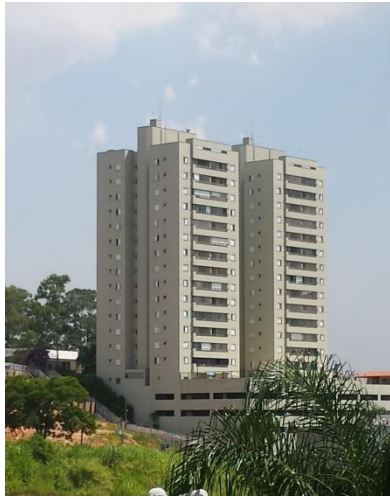
Figure 1. Identical buildings (P2 on the left, P1 on the right) with the same LPS installed.

The present study presents results from measurements of cloud-to-ground lightning flashes that struck two common identical 14-story apartment buildings (Figure 1) in São Paulo city (southeastern Brazil). The tip of their lightning rods is at a height of 52 m. Their steel reinforced concrete structures are used as natural lightning protection system (LPS). The flash density N_g for the region is about 11 flashes/km².year [1].

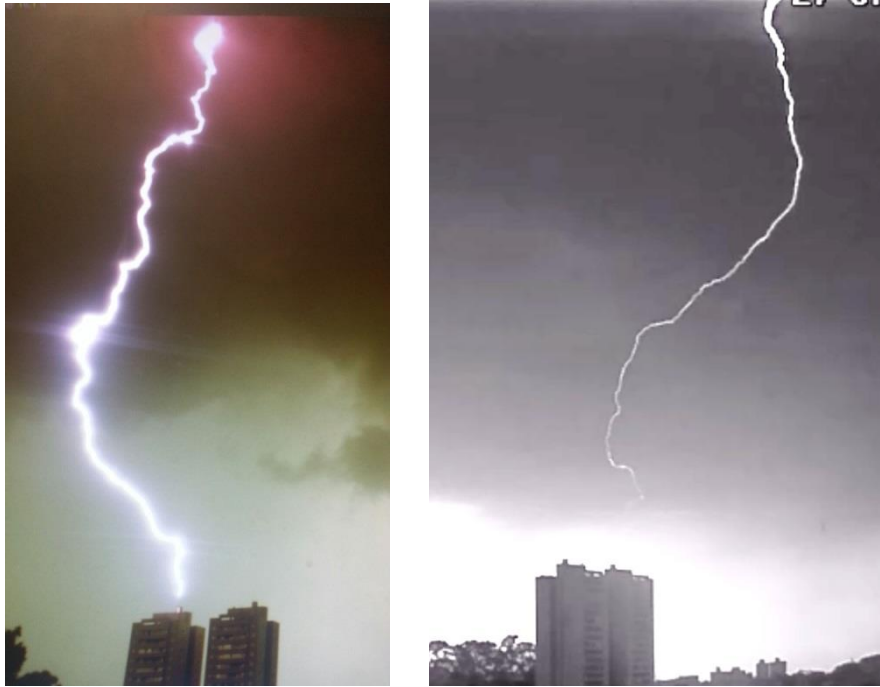
Figure 3. Images of the same lightning strike from different angles. This lightning flash that occurred on January 27, 2016 was composed of 6 return strokes.

In preparation for a study of lightning attachment, several cameras were placed in 3 different locations around the buildings. Images from different angles will help to estimate the distances of different lightning processes to the lightning rods (Figure 3). A high-speed digital video camera (Vision

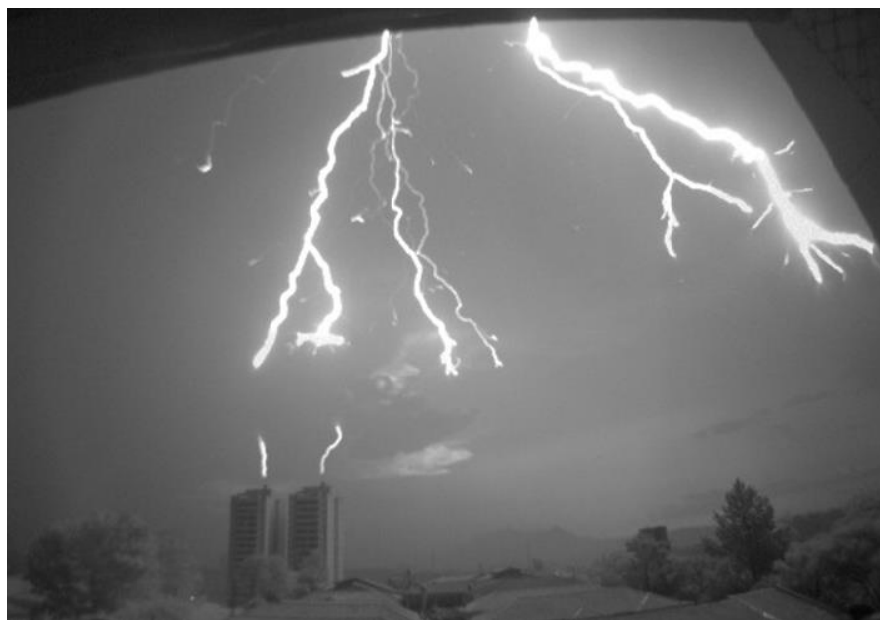
Figure 4. Image from a high-speed video of a downward leader and upward connecting leaders a few microseconds before attachment (recorded on February 9, 2014).

Research's Phantom v711) with time-resolution and exposure times of 12.5 and 100 microseconds (80,000 and 10,000 images per second) was used to record the images of the lightning attachments (Figure 4). For more details about the measuring systems and about the use of high-speed camera for lightning observations, see the works by Saba et al. [2]. All distances and speeds reported in this work are still in 2D and therefore will be underestimated.

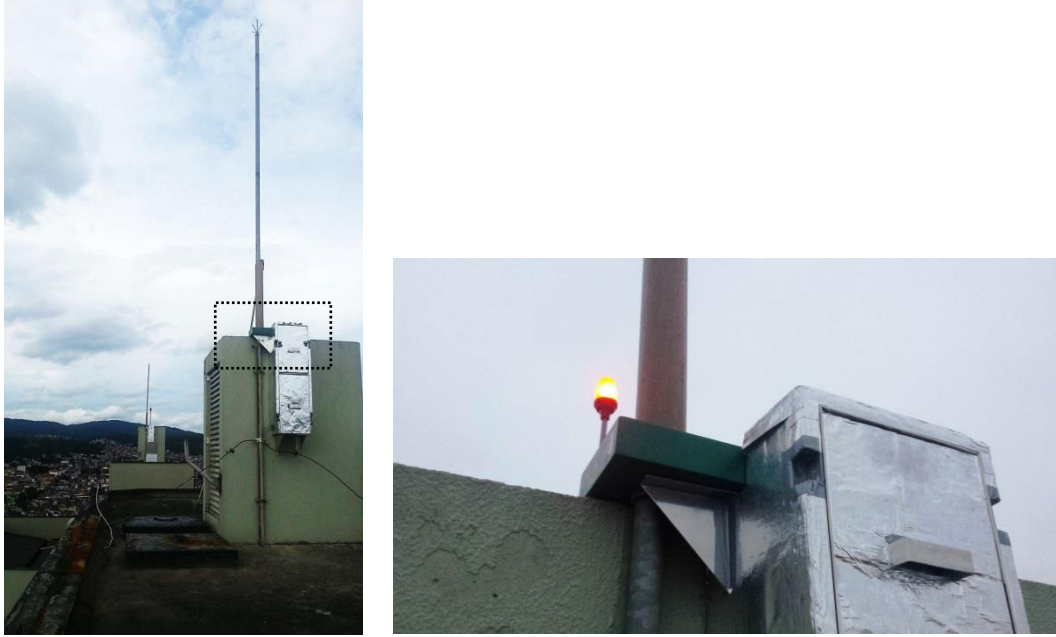
One Pearson current sensor model 310-X was installed on the lightning rod of each building (see Figure 5). This current sensor is capable of recording current up to 50,000 A with a useable rise time of 200 nanoseconds, a low frequency 3dB cut-off of 5 Hz (approximate) and a high frequency 3dB cut-off of 2 MHz (approximate). The output of the sensor is split in two channels (20 dB and 50 dB attenuation over 50Ω), and sent

to a data acquisition system through a pair of fiber optic links. Before installation, both sensors were tested and calibrated in the high voltage facility at IEE/USP.

Figure 5. Current sensor installed on the lightning rods (left) and detail of the installation (right).

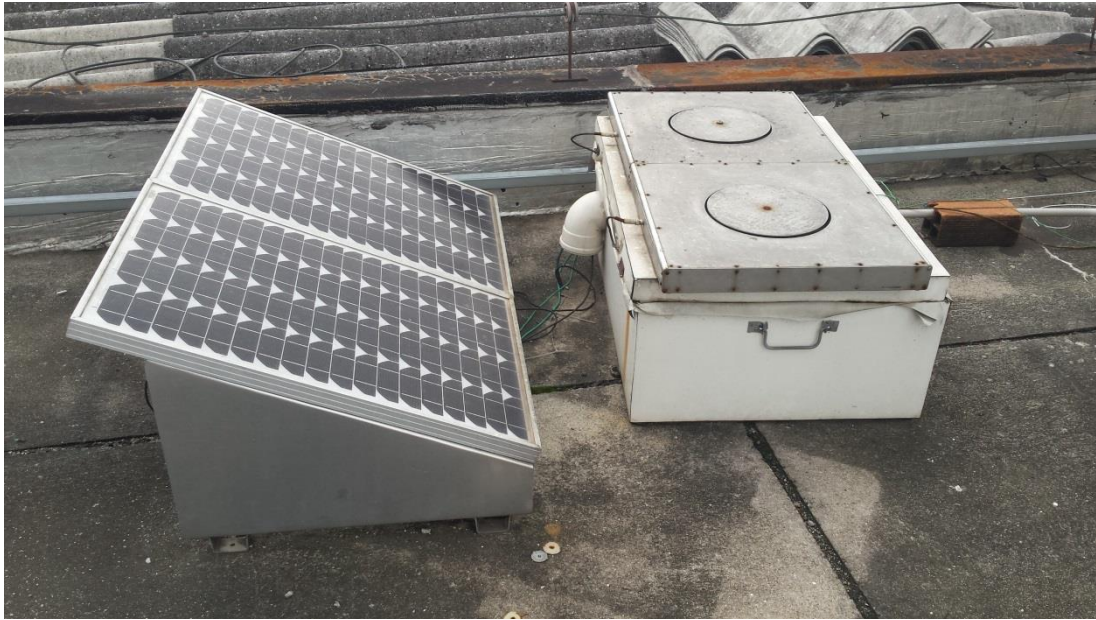
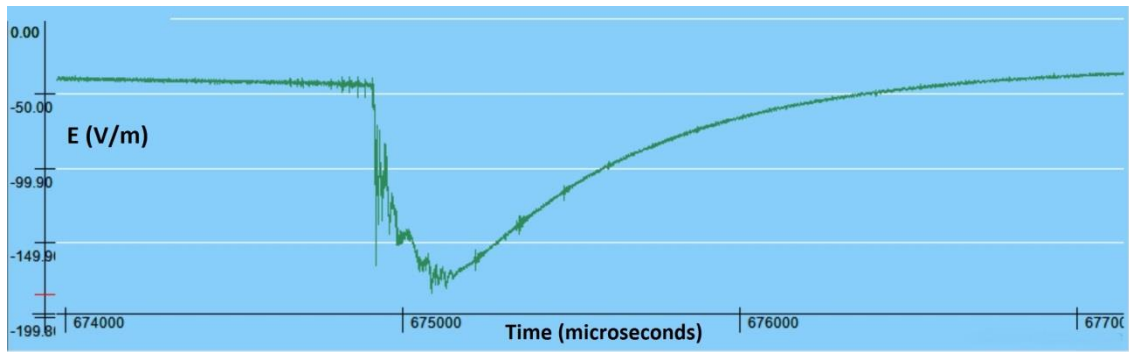
Figure 7. Electric field sensor and the signature of a lightning stroke.

The measuring system for the electric field sensor consisted of a flat plate antenna with an integrator and amplifier. Fiber-optic links were used to transmit the signal from the integrator/amplifier to the digitizer. For time synchronization a GPS receiver is connected to a PC. The sampling rate of the waveform recording system is 5 MS/s on each channel. The lower frequency and the upper frequency limits of the electric field measuring system is 306 Hz and 1.5 MHz, respectively. Four independent systems were installed. One sensor is placed on top of building P2 (at a distance of 3 and 21 meters from P2 and P1 lightning rods). The distances of the other electric field sensors to the P1-P2 buildings are: 8.5 km, 93 km and 178 km. Figure 7 shows the setup of the sensor and an example of the signature of a stroke recorded at a distance of 8.5 km from the buildings.
