Protection of Electronic Equipment Inside Buildings: A Hidden Source of Damages

Abstract — This paper shows that the criteria for the installation of surge protective devices (SPD) in power distribution panels as prescribed in standards on lightning protection and on low-voltage electrical installations may not prevent damages of sensitive electronic equipment, regardless of the protection level of the SPD and ground impedance. This is due to a not so evident source of damages related to incidental flashovers occurring between the equipment frame and grounded structures such as the floor underneath. This paper investigates this issue from experimental and theoretical approaches and provides some procedures in order to avoid such type of damages.

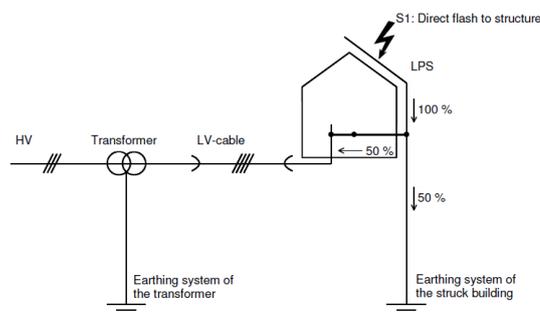
When a lightning flash strikes a building, the stroke current flows through the building grounding system and through the metallic services connected to the building, i.e. power lines, telecommunication lines, metallic water plumbing etc. Fig. 1, adapted from IEC 62305-4 [3], shows this situation for a building attended by a single metallic service (low-voltage power line). As a first approximation, the standard considers that 50% of the stroke current flows through the grounding system and the other 50% flows through the power line. This latter portion of the stroke current goes through the SPD installed at the service entrance.

Figure 1. Part of the stroke current flowing through the low-voltage power line (adapted from [3]).

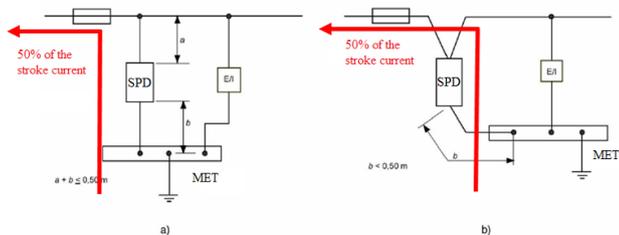
Fig. 2, adapted from [12] (also [13]), shows the restrictions usually placed on the length of the SPD connecting wires, in order to limit the inductive voltage drop. It is clear in the figure that the inductive voltage drop in the SPD connecting wires will add to the nominal protective level of the SPD.

Figure 2. Limiting the SPD connecting leads in order to limit the inductive voltage drop (adapted from [12],[13]).

The impulse current generator was modeled as an ideal generator in series with a 9 m conductor arranged in an inverted U, as shown in Fig. 13. The current delivered by the generator was forced to be 50% of the return stroke current (see Fig. 2), considering the first positive stroke, first negative stroke, and subsequent stroke. The time functions for the return stroke currents are those defined by IEC 62305-1 [15], and their peak values correspond to the Lightning Protection Level I (LPL I) of the standard.

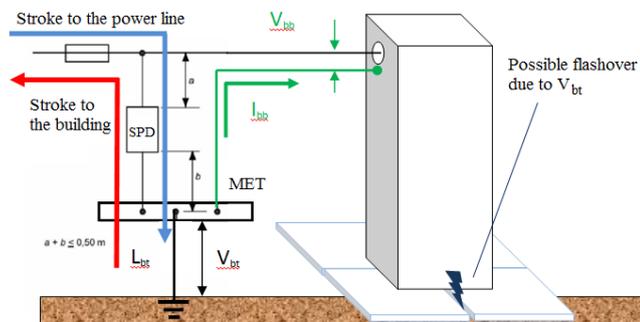
It is worth mentioning that the standards [12]-[13] do not limit the length of the conductor connecting the main earthing terminal (MET) to the building grounding system. However, as shown in Fig. 3, the inductive voltage drop in this conductor leads to an impulsive voltage between MET and ground. The longer this conductor, the higher the impulsive voltage. Moreover, part of the voltage drop across the building grounding conductors may add to the impulsive voltage. However, as shown in this paper, depending on the length of the conductor between MET and ground, flashover may occur even for perfectly conducting ground plane. As indicated by the blue arrow in Fig. 3, a similar phenomenon may occur if the power line carries a lightning surge towards the building.

Depending on the length of the conductor between the MET and the grounding system (see L_{bt} in Fig. 3), the resulting voltage V_{bt} between the MET and the ground may lead to a flashover between the equipment cabinet and ground. This flashover will lead to a current I_{bb} flowing between the MET and the ground through the equipment frame, resulting in an inductive voltage, which adds to the SPD voltage, leading to a total voltage V_{bb} between the power conductors and the equipment frame.

Figure 3. Unexpected surge current path (I_{bb}) due to flashover between the equipment cabinet and ground.

The conductors related to the voltage recorded inside the electrical panel box (see Fig. 3) were modeled by a 2 m transmission line with 20 cm between conductors. Both conductors were symmetrically connected to the lower terminal of the generator, which is 60 cm above the ground plane. Both cases were simulated, i.e. with and without flashover to ground. The flashover was simulated by connecting one terminal of the 50 k Ω resistor to ground (see Fig. 13).

It is worth to mention that there are other protective measures that can be used to mitigate the overvoltages induced in the equipment cabling by the phenomenon analyzed in this paper. Making reference to Fig. 3, it is clear that reducing the length of the connecting conductor between MET and grounding system of the installation will reduce L_{bt} and its inductive voltage drop (V_{bt}). This is an effective measure, but its application depends on the characteristics of the installation.

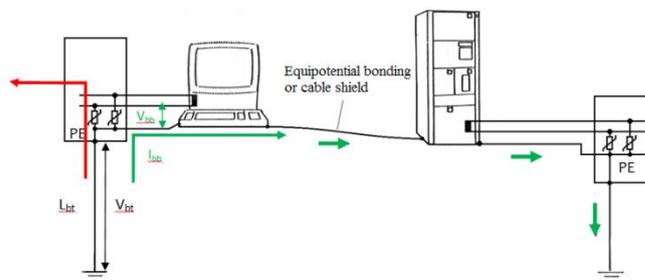
A similar situation can take place, even without flashover, when I_{bb} flows through interconnecting cables, e.g. protective PE conductors, equipotential bonding and cable shields, as shown in Fig. 4.

Figure 4. Current path through interconnecting cables.

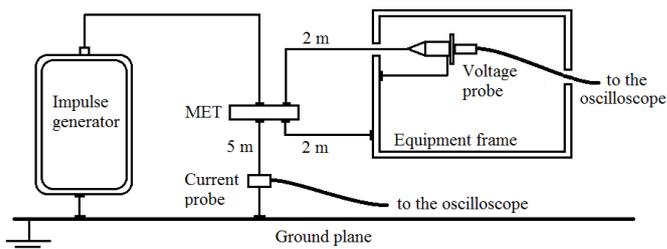
Fig. 5 shows a diagram of the test setup. The current impulse generator was connected to a ground plane formed by copper plates covering the laboratory floor. The impulse generator discharges to the ground through a copper bar intended to represent the MET of an installation, which is connected to the ground plane by a 5 m cable that passes inside a current probe (Pearson model 110). A 2 m conductor connects the MET to the equipment frame, whereas another similar conductor connects the MET to a high voltage probe (Tektronix model P6015A) installed inside the equipment frame and referred to it. This voltage probe emulates the equipment circuitry inside the frame. Note that an SPD that would be connected to the MET was replaced by a short circuit, in order to highlight the inductive voltage drop V_{bt} .

Figure 5. Description of the experimental setup.

This section presents the results of the experiments. The electrical panel box was initially placed over an insulator, as shown in Fig. 6. The impulse generator was activated, in order to inject an impulsive current to the ground plane (see Fig. 5). Fig. 8 shows the current waveform measured by the current probe shown in Fig. 5, with no flashover occurrence. As seen, this current looks like a sinusoidal half-cycle, with a duration of about 35 μ s. The current peak value reaches 14.5 kA, corresponding to a maximum time-derivative of 1.1 kA/ μ s.

Fig. 9 shows the voltage recorded inside the electric board (see Fig. 5). As expected, this voltage is relatively small, whereas the peaks result from stray capacitive coupling with the instrumentation and some inductive coupling to the wiring between MET and electrical panel box.

Fig. 11 shows the waveform of the current flowing directly from the MET to the ground plane (see Fig. 5), with 5.3 kA peak value. Assuming that the total current delivered by the impulse generator was close to the one shown in Fig. 8, it comes out that a current having peak value around 9.2 kA passed through the electrical board to ground. The higher portion of the current flowing through this path may be explained by the shorter conductor (2 m) connecting the MET to the panel box, in comparison with the one between the MET and the ground plane (5 m).

Fig. 12 shows the voltage recorded by the voltage probe placed inside the electric board (see Fig. 5), which reaches a value close to 3.5 kV. This voltage is due to the flow of the impulsive voltage through the inherent inductance of the connection between the MET and the panel box. The waveform shows discontinuities at the inception and at the end of the flashover, when the current time-derivatives reach its positive and negative peak values. The inductive nature of this voltage can also be observed from its zero-crossing at about 20 μ s, which corresponds to the peak value of the current (null time-derivative). Moreover, the voltage polarity is also related to the current time-derivative, being positive for an increasing current and negative for a decaying current. It is important to highlight that, in a real installation, this impulsive voltage will add to the residual SPD voltage, so that the resulting voltage may exceed the resistibility level of the equipment.

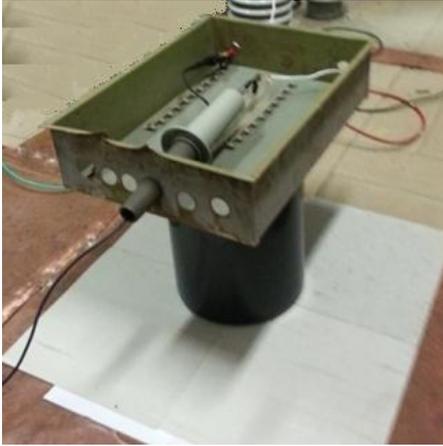
The frame of an electrical panel box (40 cm \times 30 cm) was used to emulate the equipment frame, which was placed over insulating tiles normally used as floor covering. Sheets of paper were placed between the floor tiles and the copper ground plane, in order to provide visual marks of flashover. Figs. 6 and 7 show the panel box placed off the floor and on the floor, separated by an insulator, respectively.

Figure 6. Electrical panel box over an insulator.

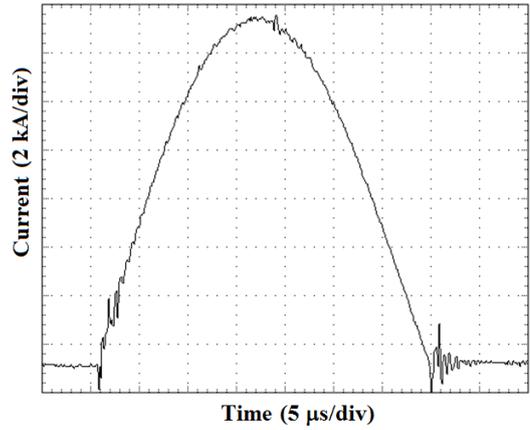
Figure 8. Current flowing from the MET to the ground plane (see Fig. 5) without flashover under the electrical panel box.

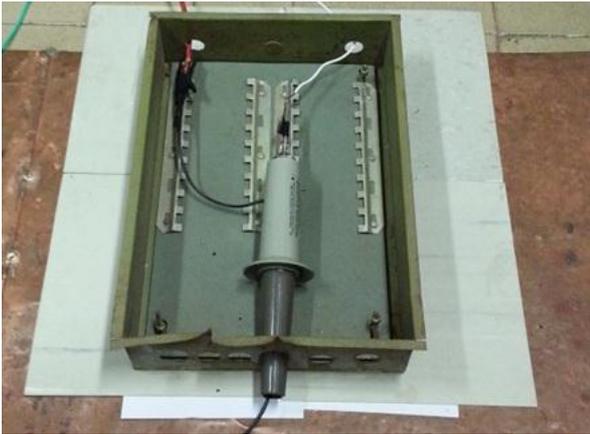
Figure 7. Electrical panel box on the floor, over insulated tiles and paper sheets.

Next, the electrical panel box was placed directly over the covered floor, as shown in Fig. 7. This situation is closer to that in real electrical installations. The experiment was repeated, with the impulse generator applying a current pulse to ground (see Fig. 5), which caused a flashover from the electrical panel box to the copper plates. The flashover was clearly identified by the charring of the paper sheets installed between the insulating tiles and the copper plane, as shown in Fig. 10.

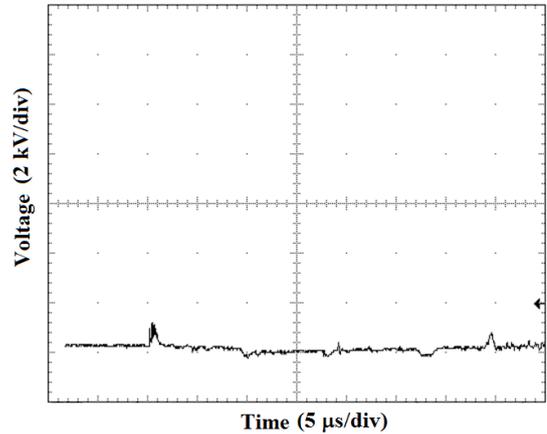
Figure 9. Voltage recorded inside the electrical panel box (see Fig. 5) when there is no flashover to ground.

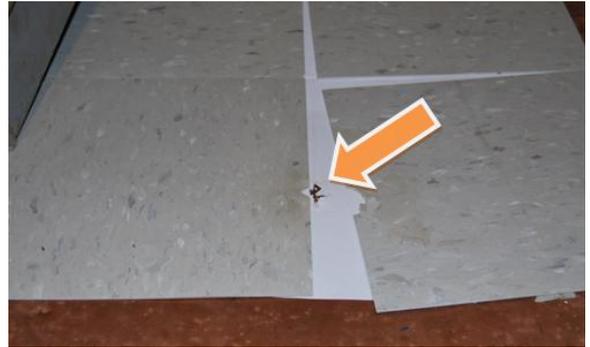
Figure 10. Charring of paper sheets due to flashover.

As shown in Fig. 10, the CM voltage between the MET and the ground plane was sufficient to produce a flashover between the electrical panel box and the ground plane. The experiment was repeated a number of times and the flashover always took place through the junction between the insulating tiles. Indeed, a previous (unpublished) investigation has shown that impulse flashover voltage at the center of similar tiles was about 50 kV, while at its borders it felt to values around 5 kV.

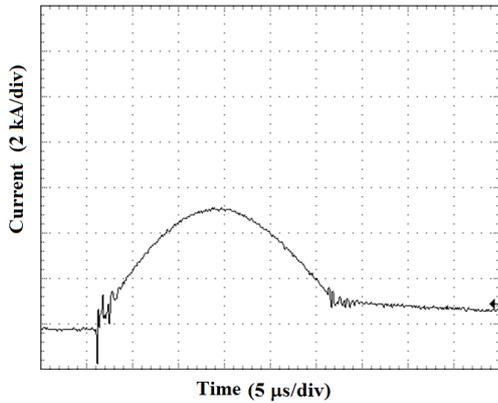
Figure 11. Current flowing from the MET to the ground plane (see Fig. 5) with flashover under the electrical panel box.

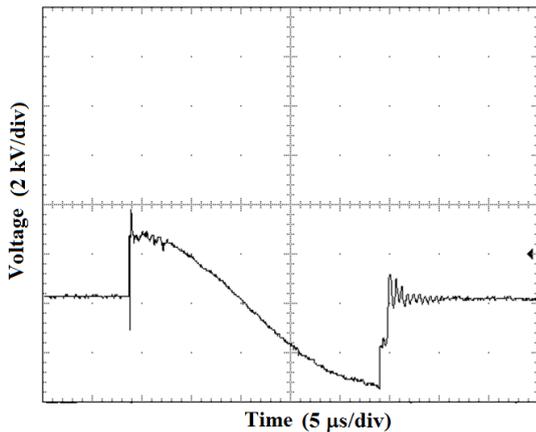
Figure 12. Voltage recorded inside the panel box (see Fig. 5) when there is flashover to ground.

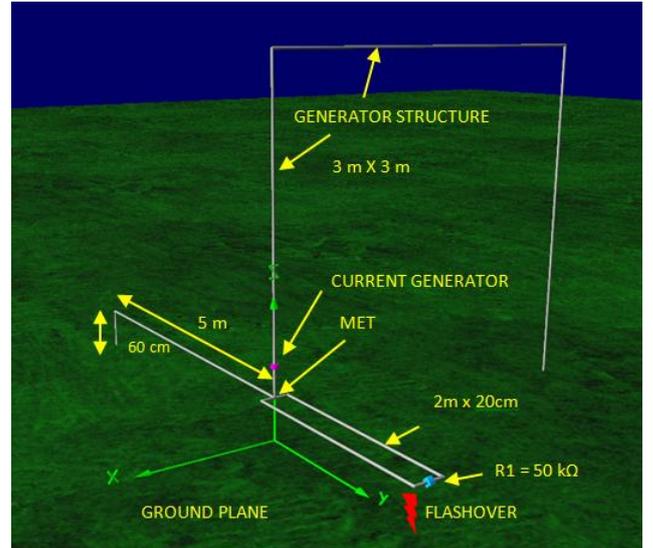
Fig. 13 shows the configuration used to model the experiment described in the previous section. The numerical calculation was carried out with software 4NEC2 [14], which is based on the Method of Moments. The translation of the results to the time domain was carried out using the methodology described in [8].

Figure 13. Model used for the numeric simulation of the experiment.

a. With flashover: one R1 terminal grounded (see Fig. 13)

b. Without flashover: both R1 terminals floating (see Fig. 13)

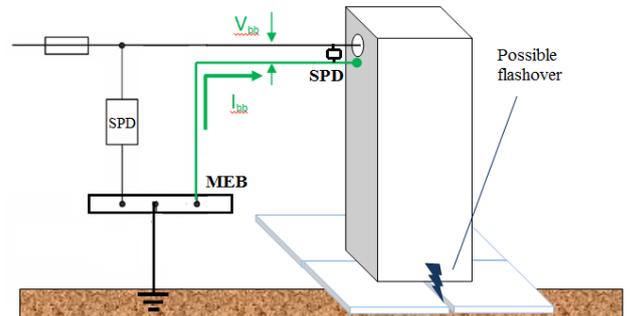
The overvoltages at the equipment input ports can be limited by the installation of SPDs between the equipment frame and the input cabling, in order to limit the common mode voltage at this very point, as shown in Fig. 14. For power conductors, these SPD should comply with IEC 61643-11 [17]. It is important that these additional SPDs be coordinated with the SPD installed at the MET. The IEC 61643-12 [18] and IEC 61643-22 [19] provide details regarding the coordination between SPDs.

Figure 14. SPD installed at the entrance of the equipment frame.

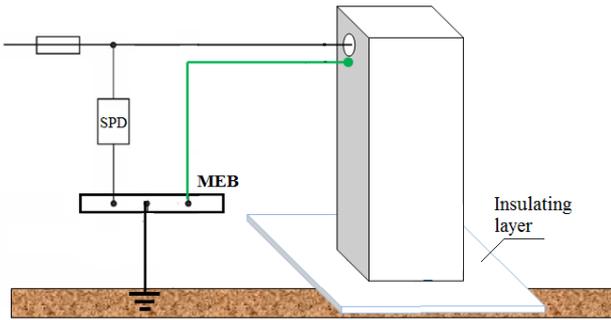
The flashover between the equipment frame and ground, as described in Section 3, can be avoided by using an appropriate insulation. Large insulating sheets can be used to insulate the equipment frame from the floor, as shown in Fig. 15. These sheets shall have no joints below the equipment and shall extend at least 10 cm from the equipment borders. Alternatively, the equipment frame may be installed on insulating feet or fixed on walls by insulating holders, providing at least 10 cm clearances to floor, walls and ceiling

Figure 15. Equipment frame insulated from the floor.

As a final remark, the use of insulating layers as shown in Fig. 15, combined with the cabling may act a LC series circuits resonating somewhere in the MF/HF bands making the installation prone to interference if close to RF sources operating in these frequency bands.

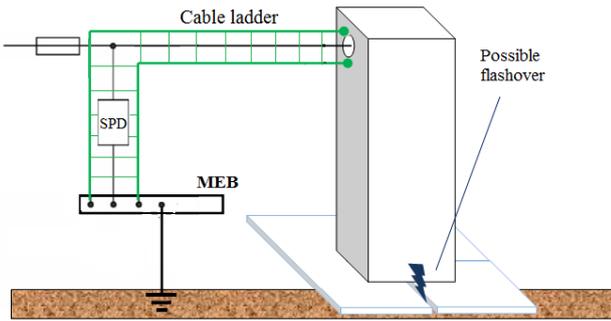
The use of metallic trays or ladders to carry the conductors from the MET to the equipment frame is an effective measure in order to mitigate the overvoltages applied to the equipment ports. In order to be effective in reducing this overvoltage, the cable trays and ladders must be electrically continuous and solidly bonded to the MET and to the equipment frame, as shown in Fig. 16.

Figure 16. Use of metallic cable ladder between the MET and the equipment frame.

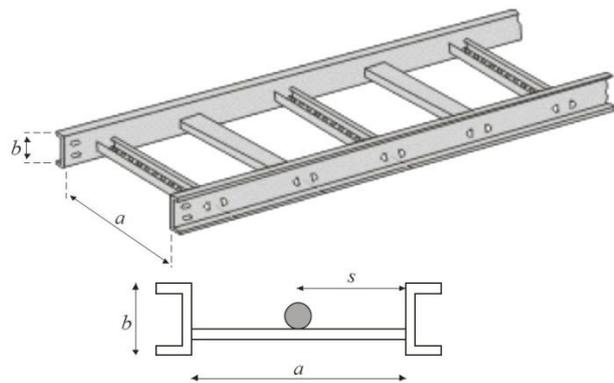
The reduction in the overvoltages due to the use of metallic cable trays and ladders can be assessed by the shielding factors provided by ITU-T K.56 [22]. In the Annex A of this standard it is stated that the shielding factor provided by a closed metallic tray or duct is nearly zero, i.e., the overvoltages are completely removed. On the other hand, the shielding factor provided by a cable tray or ladder that has no electrical continuity is one, i.e., it does not reduce the overvoltages. Tables II to V, adapted from [22], provide the shielding factors for different types of cable ladders and trays, which are described in Figs. 17 and 18, respectively.

Figure 17. Cable ladder considered in Tables II and III.
