Coordination of surge arresters in DC 3 kV railway traction system— field tests

Abstract—This paper presents field tests of surge protection devices used at railway lines in Poland. Two types of arresters have been investigated: a horn air spark gap and a varistor. The aim of the field tests was to verify the possibility of coordination of both types of arresters at railway line under normal operating conditions of the electric traction system 3 kV DC.

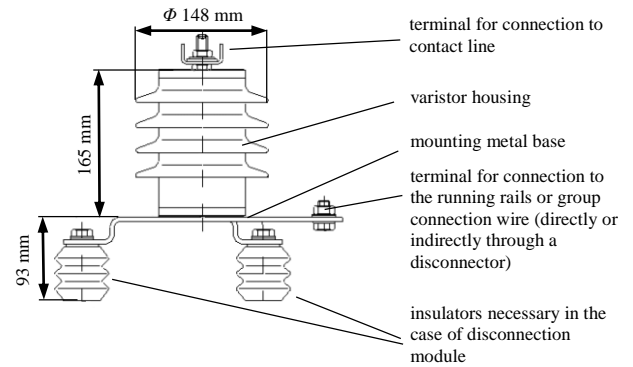
Figure 3. Varistor arrester type PROXAR IV 4.5

Varistor type arrester is a voltage limiting device, which impedance – very high in normal operating conditions – changes continuously during overvoltages occurrence. Consequently – contrary to the air spark gap – during its operation, varistor does not cause direct short circuit of electric traction system and therefore there is no following current phenomenon. Currently at traction system of the PKP Polish Railway Lines, Inc. varistor arresters type PROXAR IV 4.5 (Fig. 3) are mounted at feeders in traction substations. Basic parameters of PROXAR IV 4.5 varistor are as follows:

- nominal discharge current I_n : 20 kA 8/20 μ s;
- high current impulse I_{hc} : 200 kA 4/10 μ s;
- voltage protection level: 11,80 kV at 20 kA 8/20 μ s.

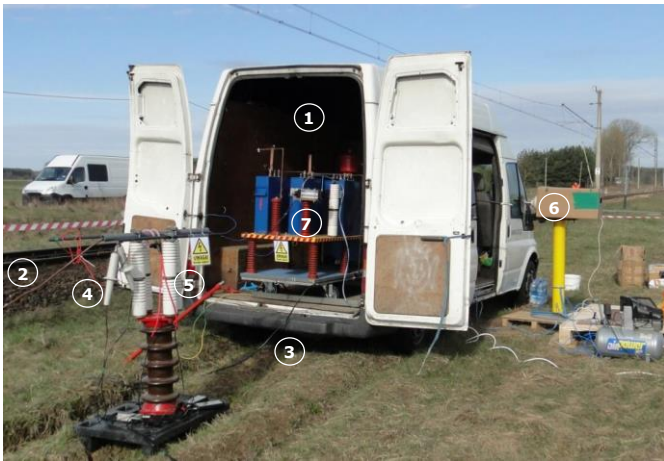
Figure 4. Surge generator post:

1) surge generator; 2) output of the generator's positive pole for connection to the overhead feeding wires + DC 3 kV; 3) output of the generator's negative pole for connection to the running rail or traction mast; 4) high voltage probe at generator output; 5) current probe at generator output; 6) kilovoltmeter for control measurements of voltage loading of capacitors; 7) pneumatic switch to key surge

During the field tests a mobile high voltage surge generator was used (Fig. 4.). The main part of the generator was located inside a delivery truck to facilitate transportation to the test site. Maximum voltage at open output of the generator was 40 kV

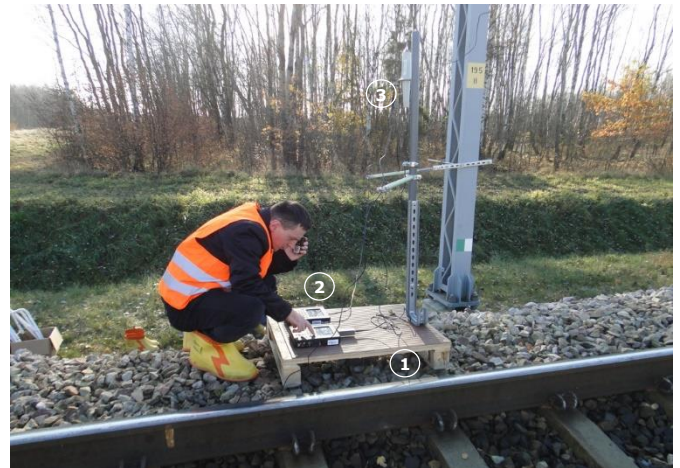
Figure 5. Local measurement post - currents and voltages of SPDs:

1) special support construction for high voltage probe suspension for traction voltage measurements; 2) movable oscilloscopes; 3) high voltage probe

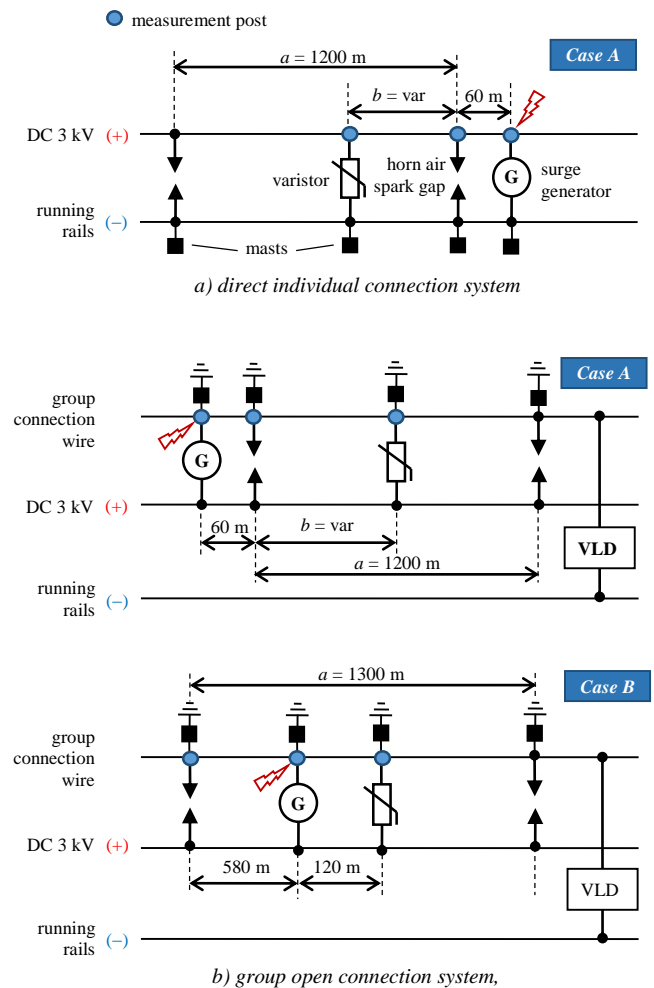
Figure 6. Configurations of field test:

a) direct individual connection system; b) group open connection system; Case A – simulation of lightning strike near a horn air spark gap; Case B – simulation of lightning strike near a varistor

connected at different locations to investigate the effect of the distance b between both types of arresters (Fig. 6).

At both field tests *Case A* of direct strike near an air spark gap, simulation was investigated. The Generator was connected to the railway at about 60 m (distance between masts) from the mast with the nearest air spark gap installed. Varistors were connected (one varistor at a time) on the opposite side at different distances from the air spark gap $b = 60$ m, 120 m, 180 m, 300 m, 600 m (middle of section between air spark gaps).

Case B – simulation of direct lightning strike near a varistor – was investigated only at field site with open group connection system. The Generator was connected about 120 m from the varistor installed in the middle section between two air spark gaps (Fig. 6b). The Distance from the varistor to the air spark gaps at both sides was respectively 700 m and 600 m.

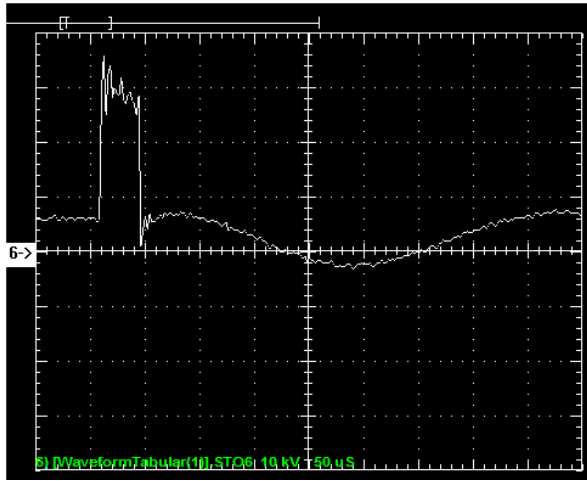
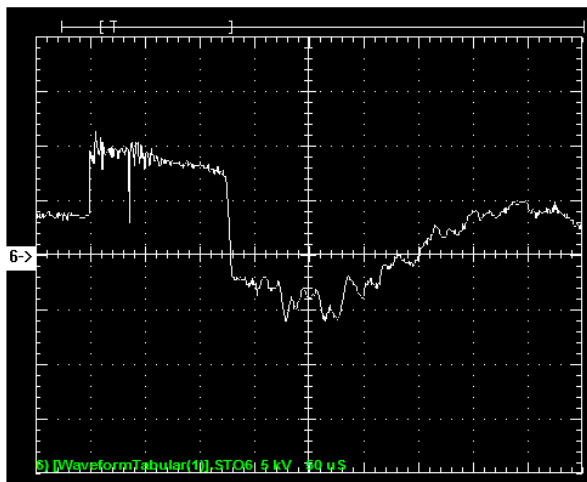
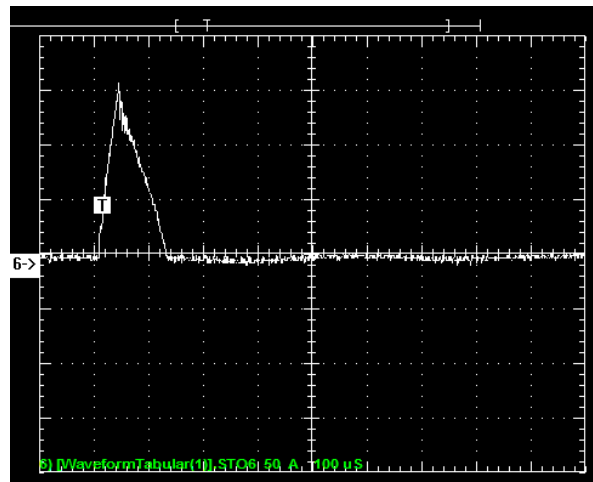
10 kV/div, 50 μs/div

5 kA/div, 100 μs/div ($I_{\max} = 8 \text{ kA}$)

a) Voltage and current of a horn air spark gap

5 kV/div, 50 μs/div

250 A/div, 100 μs/div ($I_{\max} = 0,75 \text{ kA}$)

b) Voltage and current of a varistor

5 kA/div, 100 μs/div ($I_{\max} \approx 9 \text{ kA}$)

c) Surge current at generator output

Figure 9. Voltage and current waveforms of a horn air spark gap and a varistor at railway line with open group connection system in the case of simulation of direct lightning strike near an air spark gap (configuration according to Fig. 6b - Case A, distance between arresters $b = 600 \text{ m}$)

The exemplary results of coordination for *Case A* are presented in Fig. 9. Voltage and current waveforms measured at the horn air spark gap (Fig. 9a) and the varistor (Fig. 9b), and surge current at the generator output (Fig. 9c) are presented for the situation of the railway line with group open connection system and the distance between arresters $b = 600$ m. In the case of the presented results, the most of a surge current was intercepted by the horn air spark gap, therefore this situation is a precise coordination example of the arrangement of two SPD types. The other results, where air spark gap was also operating, show that the value of current flowing through a varistor increases with the reduction of distance b between arresters.
