High Voltage Impulse Experiment on Electric Automobiles and its Verification Part2

Abstract— We applied impulse voltages to an electric vehicle using an impulse voltage generator. The results provide insight into the phenomenological aspects of lightning strikes and characteristics of electric discharge between the wheels and ground.

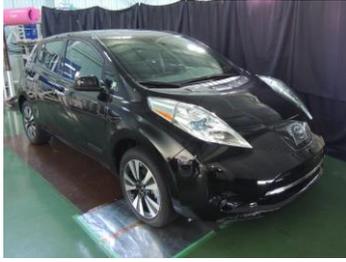
Fig. 1 shows the vehicle body and Fig. 2 the vehicle dimensions. The vehicle body was arranged on a copper plate simulating the ground, and the copper plate (3 mm thick) were

Figure 1. Schematic of specimen placement.

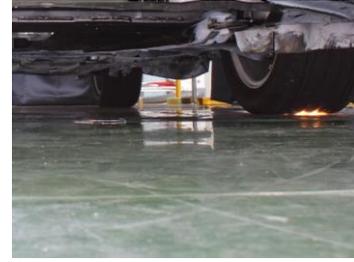
Figure 8. Photograph of electric discharge interior of left front wheel.

In the first phase of the test, electric discharge at the left front wheel inside shown in Fig. 8 was frequently observed. It was assumed that as the test was repeated, the discharge path was formed and electrical current tended to be easily discharged at the same portion. In the present test, with the formation of discharge path taken into account, the contact areas of tires were changed several times during the test. The contact areas were four surfaces of 0°, 90°, 180°, and 270°, and the contact area right after the test was started was set to 0°. In addition, when the distance between the aluminum wheel rim end unit and the copper plate (hereinafter called the “tire

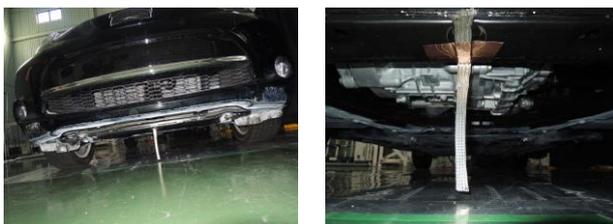
(a) Photograph of body bottom (b) magnification

Figure 10. Braided wire connected body bottom.

Table 6(b) includes the result of preliminary experiments. Authors conducted similar experiment with other electric vehicle in the past[10], and obtained the knowledge in that there was a possibility for an electrical current to be easily discharged at places with small tire pressure. Therefore, as shown in Fig. 10, a braided wire was connected to the metal part of vehicle body bottom surface and a path through which an electrical current was easily discharged was intentionally formed. The braided wire was adjusted to provide about 2 cm gap length with respect to the copper plate (about 14 cm long: the lowest ground height of the specimen assumed to be 16 cm). When the voltage is applied under this condition, discharge was able to be identified not at the tire but at the braided wire part.
