Damage Mechanism of PVC and Balsa Wood Used in Wind Turbine Blade under Thermal Effect of Lightning Strikes

Abstract—At present, PVC and balsa wood are usually adopted in the sandwich structure of the wind turbine blade. However, comparative research on the damage characteristics of the two materials under lightning arc is seldom reported. Large current experiment was conducted on PVC and balsa wood, which indicated that under the surge current, there was a more severe reduction in the residual strength of PVC than balsa wood. By the means of molecular reaction dynamics, the chemical reaction process, gas generation characteristics and water motion of the materials were studied quantitatively. As is shown in the visual results, cellulose (main component of balsa wood) was gradually splitting with the degree of polymerization(DP) reducing as time increasing, while there is no obvious change on the DP in the PVC aspect. The degradation of cellulose generated relatively more kinds of small-molecule gases while PVC mainly produced HCl and small amounts of olefins, but the number of gas products from PVC pyrolysis was far much more than that of cellulose. In addition, with many $-OH$ 、

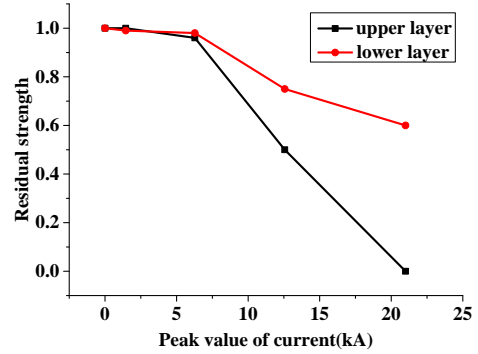
Figure 2. Curve of residual strength vs current peak value(balsa wood)

To comparatively study the damage degree of PVC and balsa wood, the residual strength in the depth direction was measured, as shown in Fig. 2 and Fig. 3. The residual strength decreased obviously as peak value of the current increased, and the decreasing speed of the PVC was larger than the balsa wood.

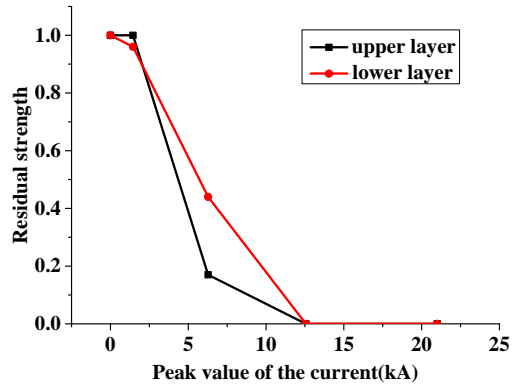
Figure 3. Curve of residual strength vs current peak value(PVC)

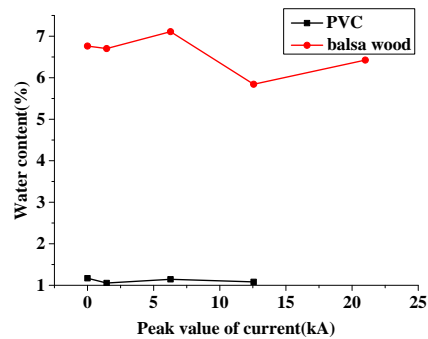
Figure 4. Curve of water content vs current peak value after experiments

Amorphous cell of two materials with same volume were built using the Builder module of ADF, considering the actual degree of polymerization (DP) and water moisture of PVC and balsa wood(water moisture of PVC and balsa wood after the experiments is shown as Fig. 4), and also to save the calculating time, 1 cellulose molecular with DP of 16 and 12 H₂O, 12 PVC molecular with DP of 3 and 2 H₂O were respectively added in the cells. Target density were set as 1.599g/cm³ and 1.35 g/cm³, and the molecular model are shown in Fig. 5 and Fig. 6.

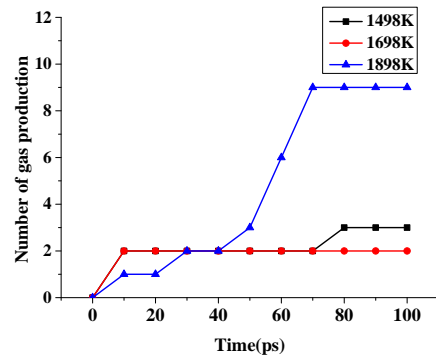
Figure 10. Curve of number of gas products of cellulose vs simulating time

The degradation mechanism of cellulose is complicated, and it has many kinds of production with different states, among them, CO, CO₂, H₂O, H₂, and also some organics with low carbon content will escape to result in gas pressure; As for the PVC, it mainly produces HCl and a small amount of alkenes. The statistics of gas production is shown in Fig. 10 and Fig. 11, PVC produces more gas production and it suffers larger stress from gas production expansion.
